## The Problem

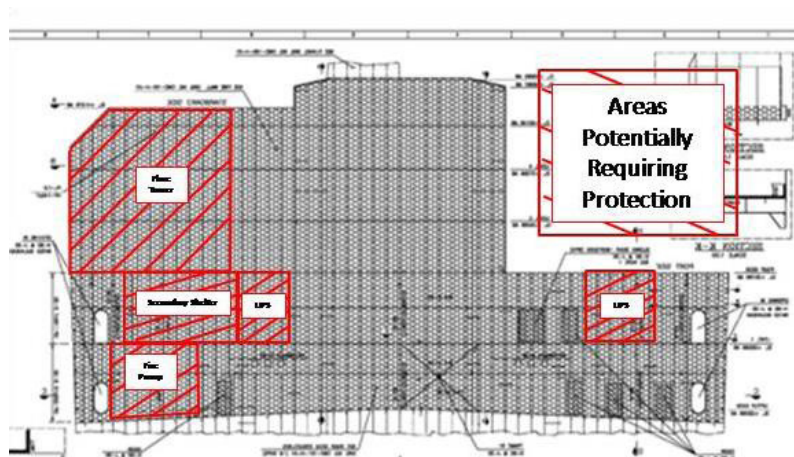
When a new FPSO came into service, the operator noticed some blistering of the aft firewall and asked us to take a look. This firewall was an important protection for the crew quarters and lifeboats at the stern of the ship, so we sent one of our experts out to investigate.

Our expert quickly concluded that not only had the Passive Fire Protection (PFP) coating been badly applied, the wrong PFP material had been initially specified. The only solution would be to strip off the current layer, and apply a new one. During this process the firewall's ability to protect the crew quarters would be severely impaired, and production might have to be halted.

To check if it would be possible to continue production without the PFP, we undertook some detailed fire modelling and structural response analysis, and concluded that without the PFP the heat coming through the wall would make it impossible for crew to approach the lifeboats. However, we were able to suggest a temporary water deluge system that would spray the firewall with cooling water and provide sufficient escape time.

Meanwhile, another of our experts had developed a novel method for removing the old PFP that massively reduced the amount of slurry waste generated, and required a smaller team to execute. With a progressive repair technique developed and a solution to the continued safe operation of the vessel, we were able to work with the certification and safety authorities to approve the programme.
