# Are Unsafe “Fireproofing” Practices Still Being Used in Oil & Gas and Petrochemical Processing Plants?

**G. Boaler, R. Holliday & E. Walker**  
[www.mmiengineering.com](http://www.mmiengineering.com)

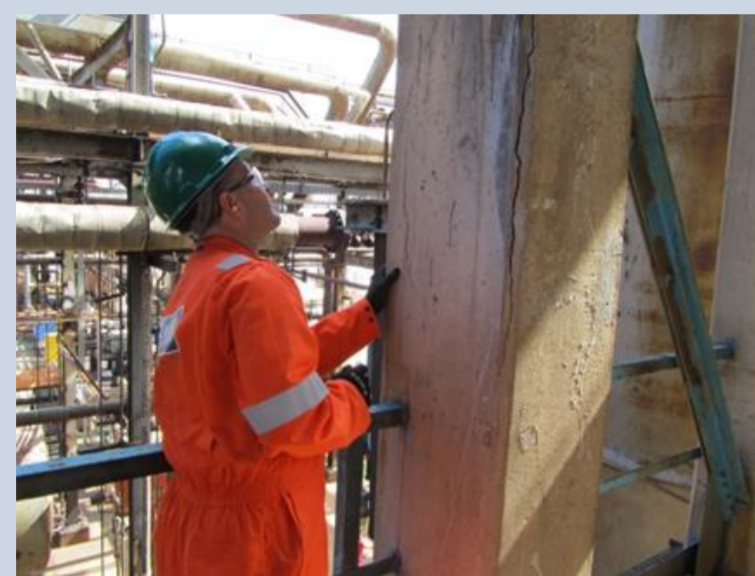
*The pre-fire durability, explosion resistance, fire capability and reliability of the hollow encasement, “box”, design fireproofing (figure 1) is found to be inherently flawed, but remains a preferred method with some stakeholders in Asia, Middle East, Europe and the United States. Here we discuss why the design is obsolete and reasons why the practice continues*

Figure 1 shows typical boxed “fireproofing” arrangement details from a project specification.

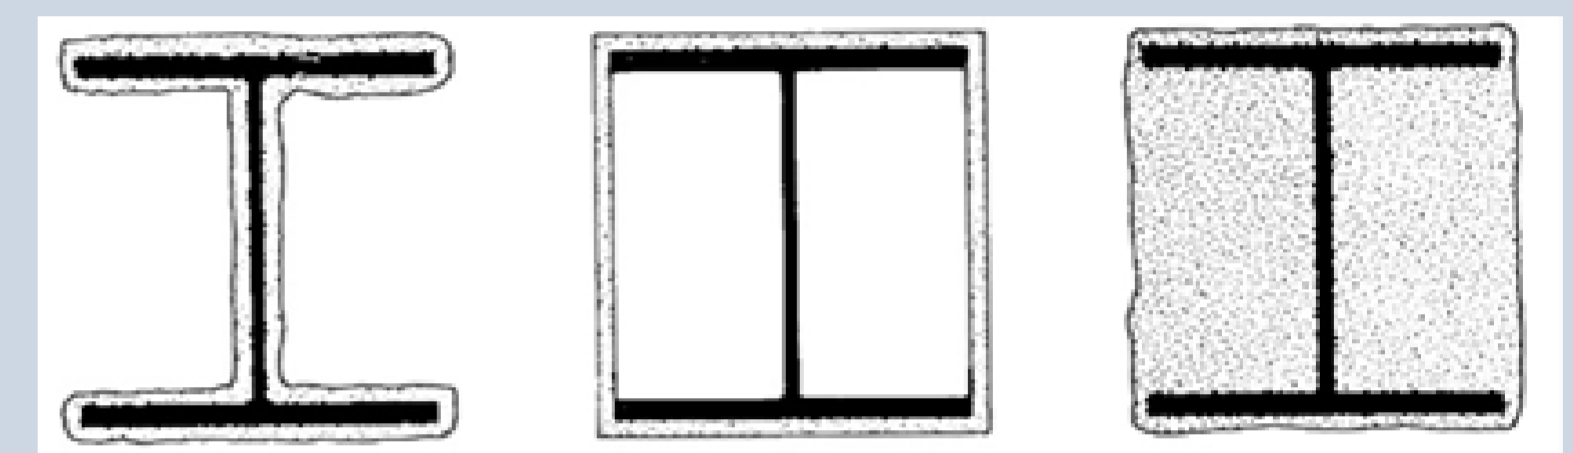
Figure 3 shows the generic design techniques for the protection of steel structures left to right; profile, boxed and solid fill (note solid fill designs are used on sections typically up to 203mm deep)

In considering LWC systems there are critical distinctions in performance between profile, box and solid fill methods of design as shown in Figure 3.

Because of a wealth of negative experience over decades in the pre-fire phase and in fire events boxed designs were effectively obsolete in external process plant in most of Asia, ME and Europe by 1983.

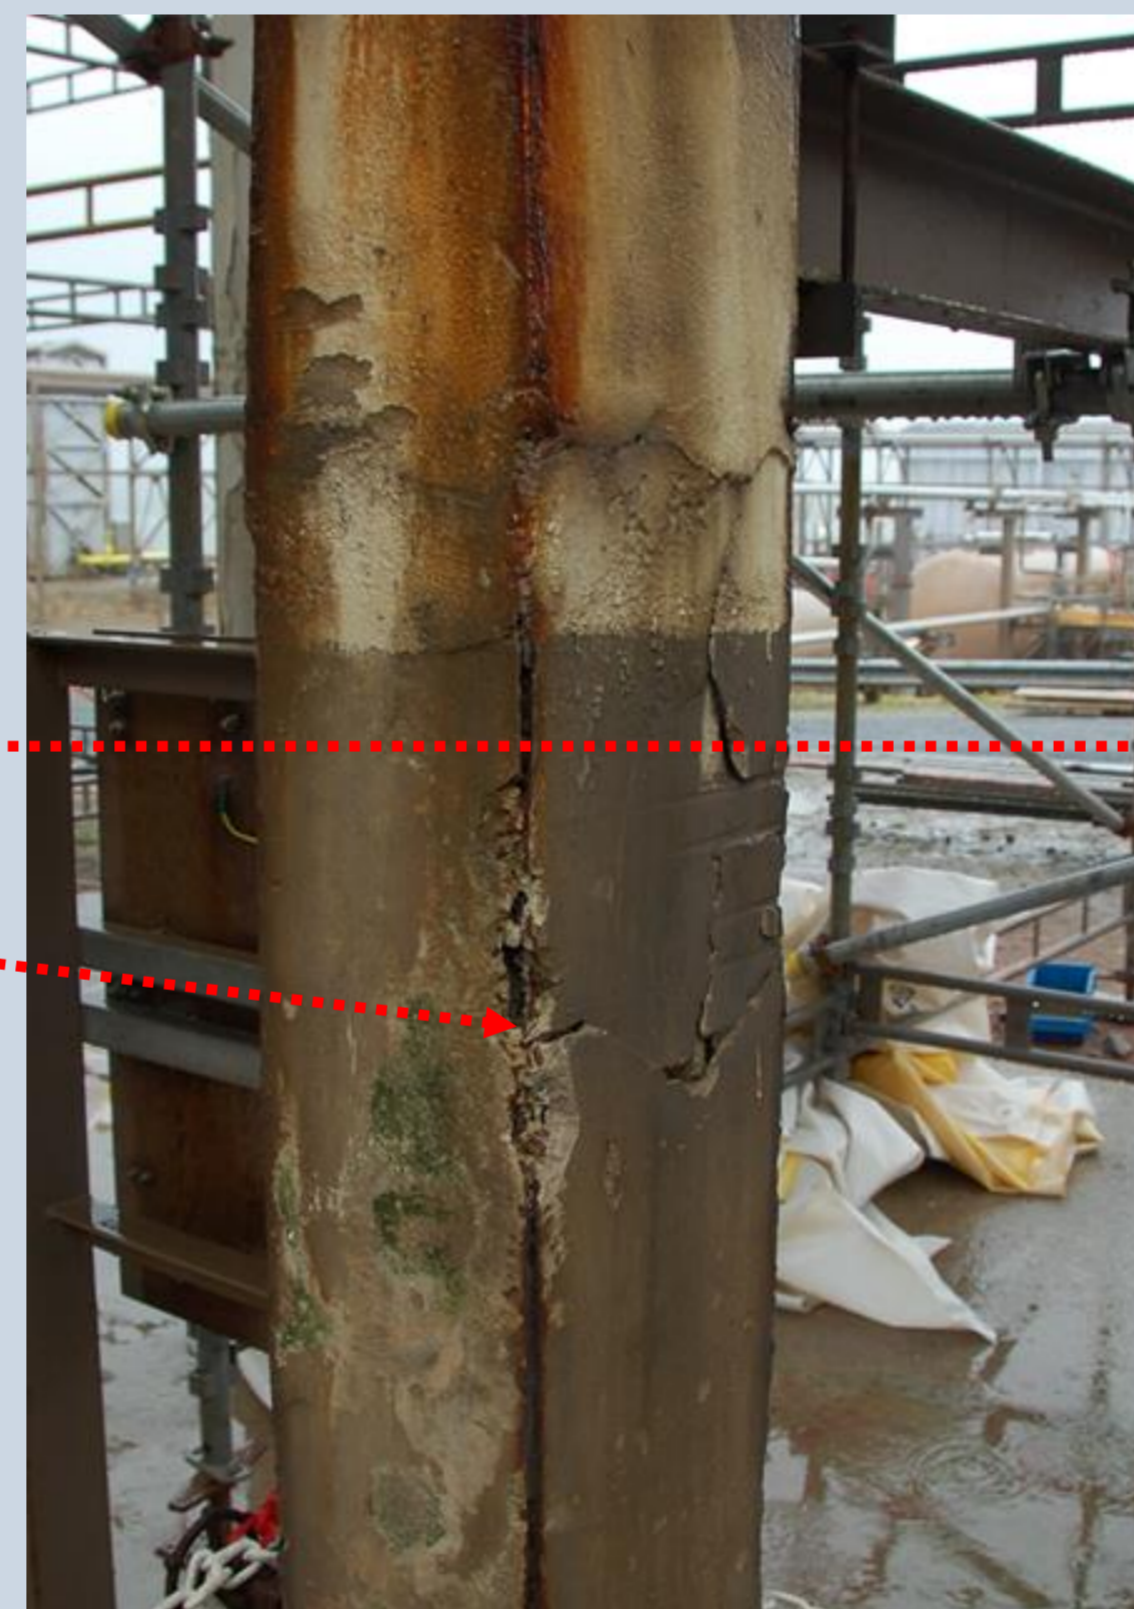
Figure 5 shows typical anomalies; the corner angle bead has corroded, the coating is detached and mechanical damage has compromised the arrangement.

A “corner bead” component (figure 4) often galvanized steel sometimes plastic nosed, open leg, wire may be proposed as an application aid to form straight, square edges in boxed designs as shown in figure 5. An angle bead detail has been found to be a particular weakness in the design. The boxed detail is particularly vulnerable to mechanical impact damage.

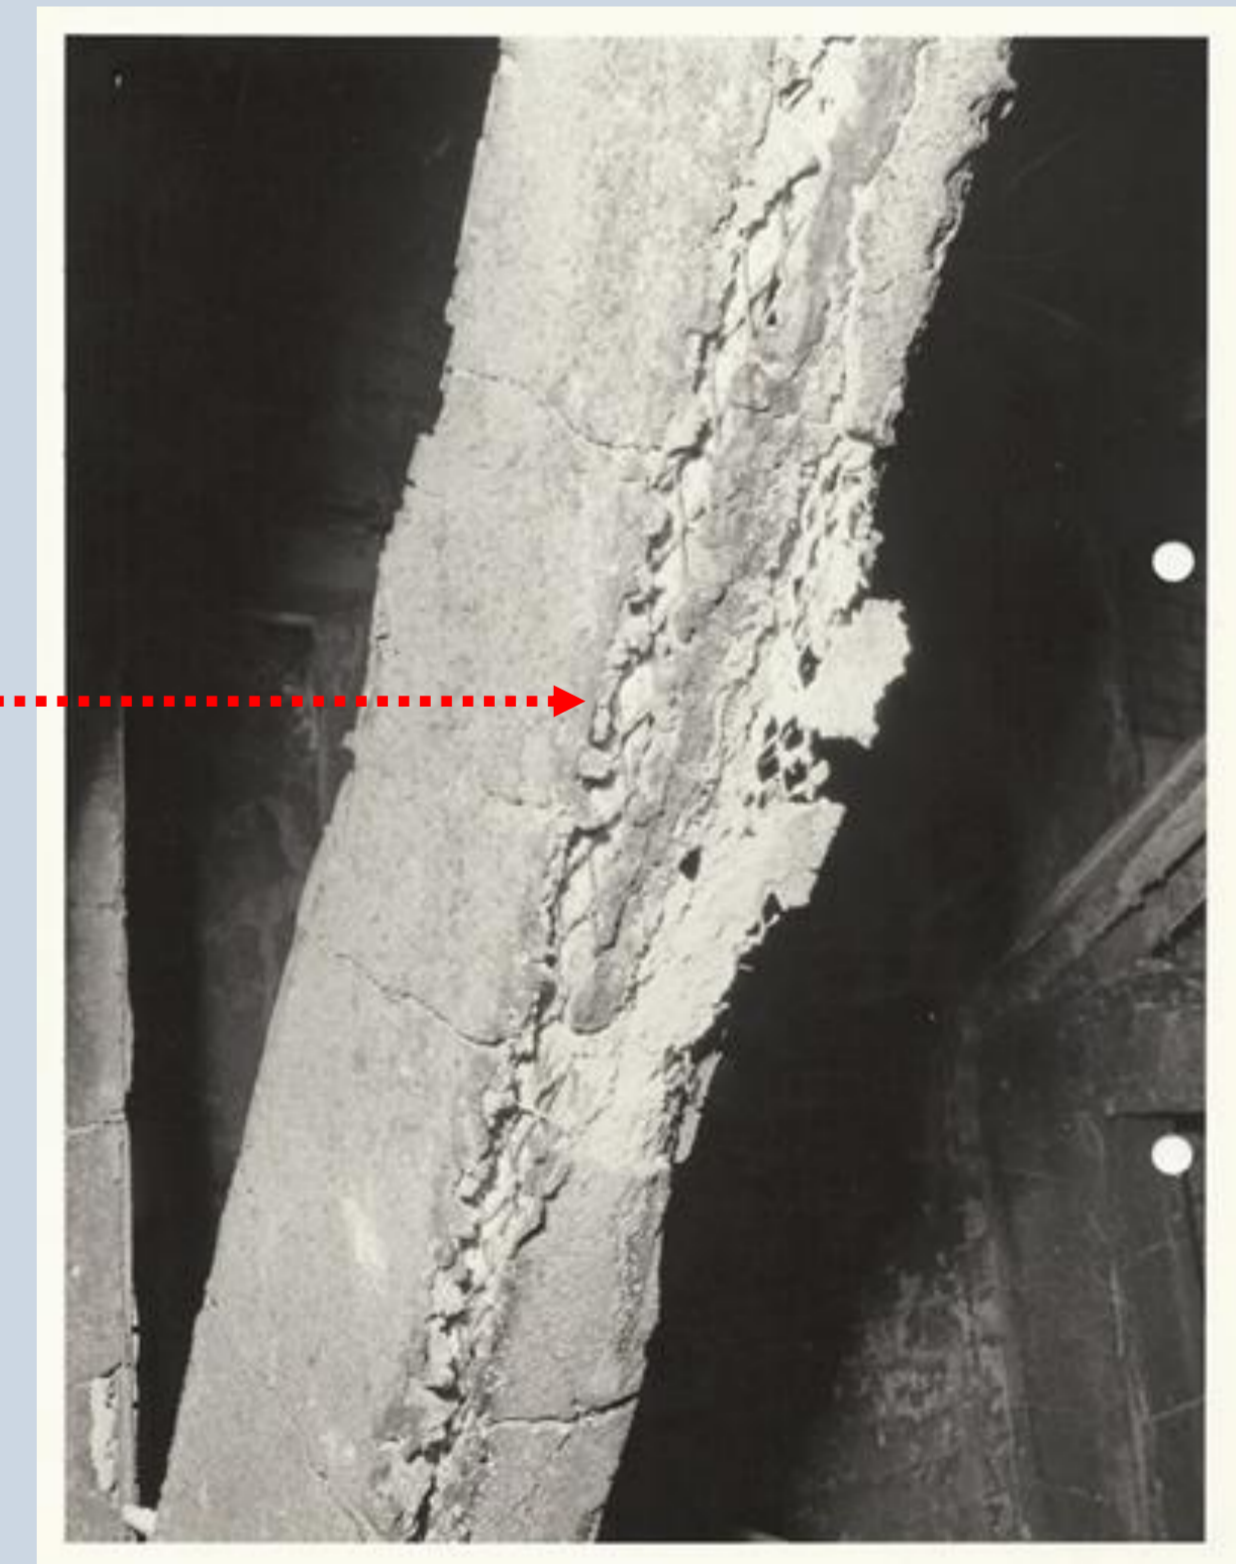
Figure 6 Premature failure of PFP due to effect of angle beads in a fire event in 1977

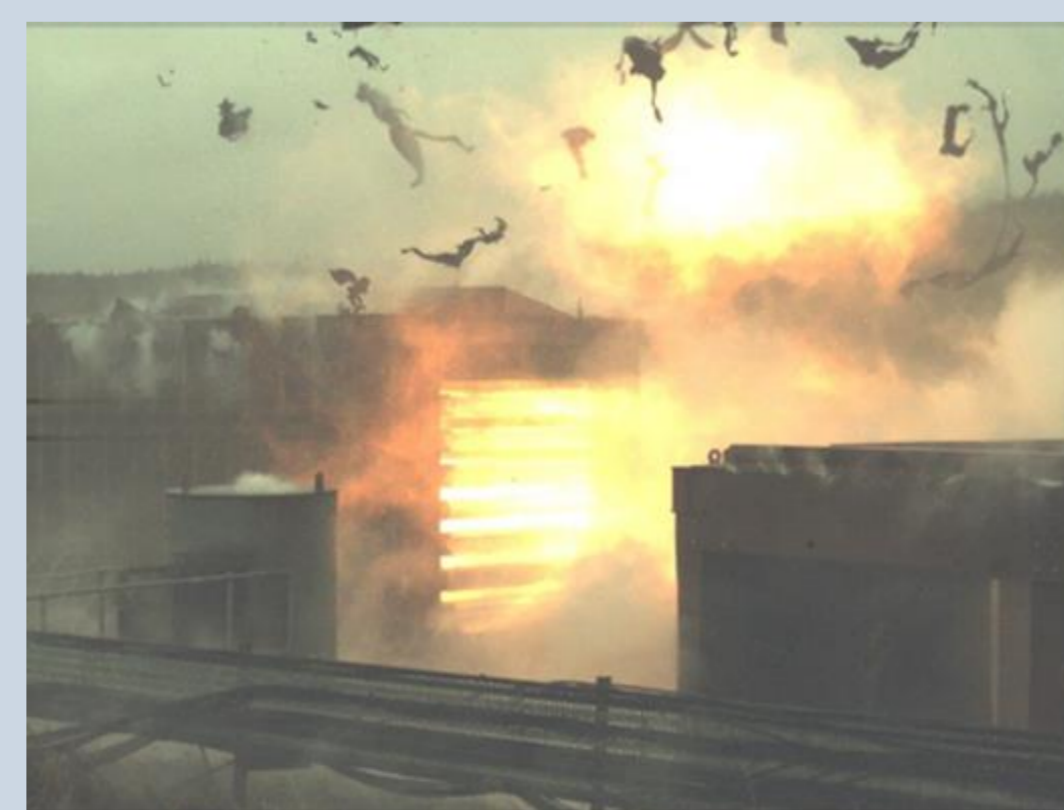
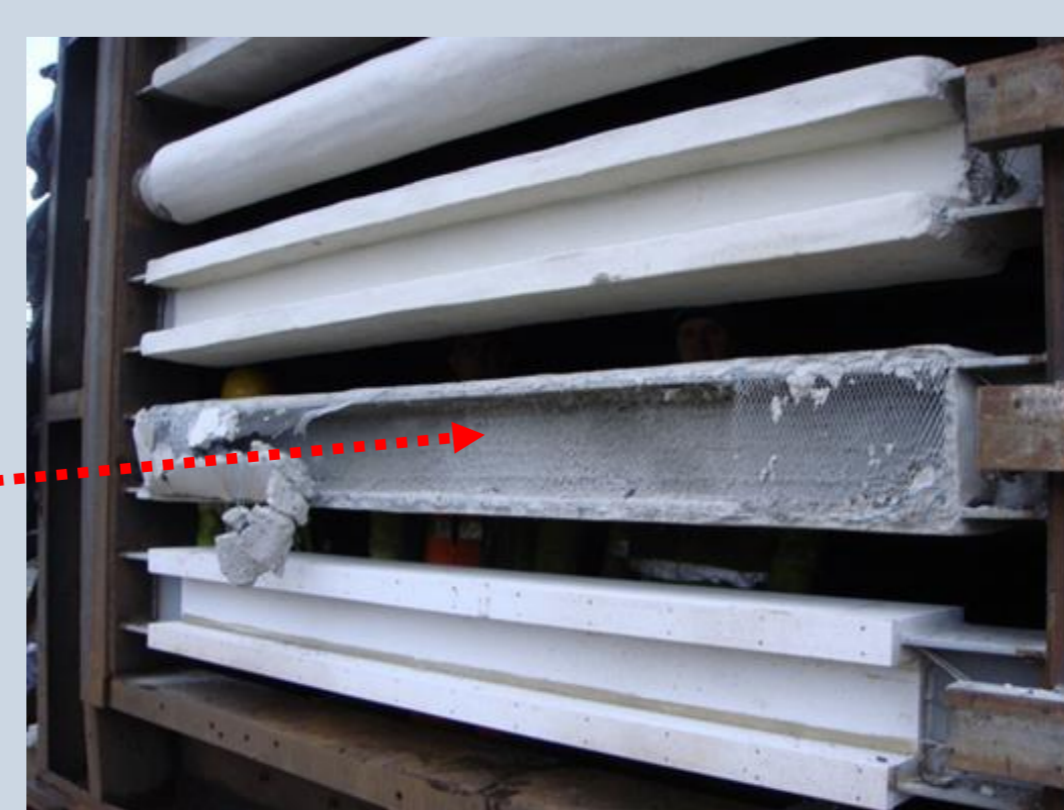
Figure 7a & 7b shows a blast loading response demonstration and the comparative performance of profile and boxed designs

The comparative response of the designs to blast overpressures has been starkly illustrated in testing.

In the image Figure 7b the LWC on the boxed design has been destroyed, leaving the web exposed and rendering the arrangement ineffective in fire events, whereas the profile design remains intact and ready to perform its intended purpose in a fire event.
