The Problem

During inspection of a crude oil tank header at an onshore terminal, a number of areas were identified in which corrosion of the pipe material had occurred. In total, there were 8 areas of degradation reported. The client requested MMI to undertake an API 579 Level 3 based assessment of the oil tank bridle pipework and interconnection line to demonstrate continued fitness-for-service of these locations.

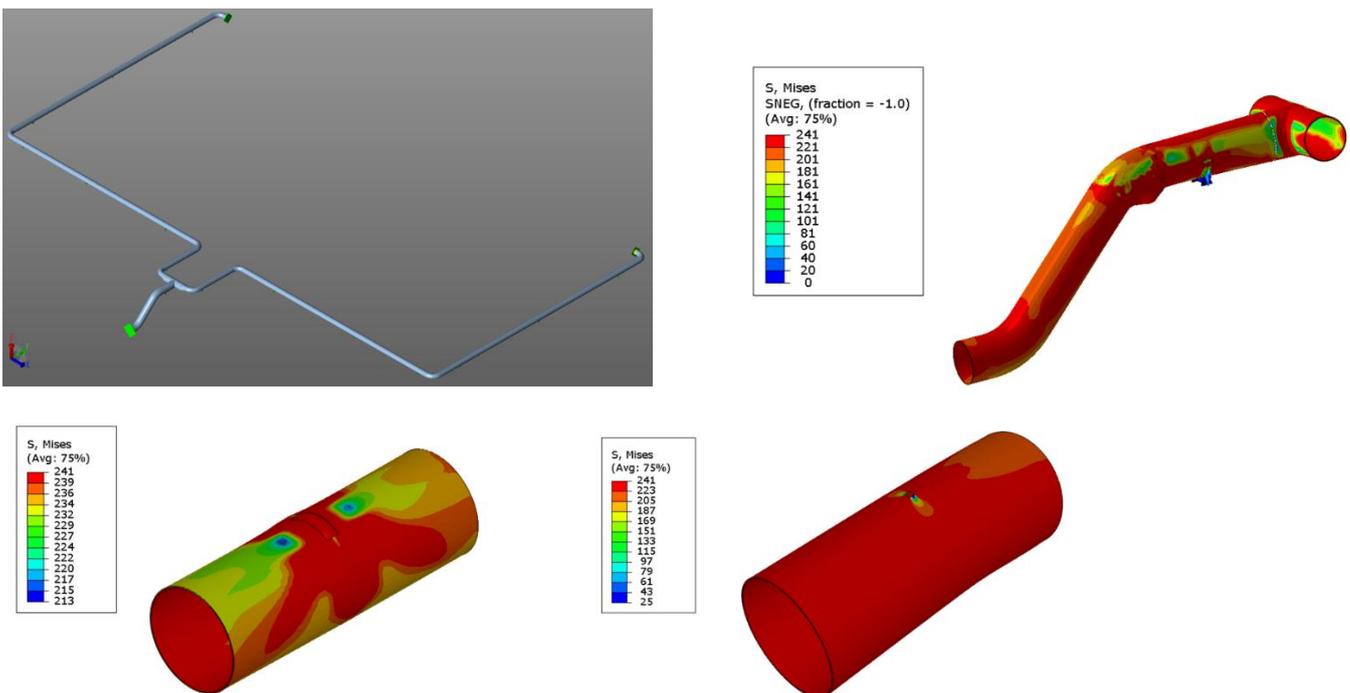
- (1) Pipe stress analysis using CAESARII to determine the forces and moments in the corroded pipe sections due to thermal expansion and pressure loading.
- (2) The loads and moments obtained from the model were applied to the localised finite element models incorporating the areas of metal loss, and incremental collapse analysis using Riks method was carried out to predict limit collapse load for each defect.

The results showed that the limiting location had a minimum collapse pressure of 2.3 MPa (23 barg), compared to a design pressure for the system of 15 barg, a margin of 1.53 x design against yield stress. Compared to the nominal pressure vessel code margin where the allowable stress is taken as 2/3 yield stress (i.e. a factor of 1.5x) it was considered that the crude oil tank header at the terminal remained fit for continued service at 15 barg. For all other locations of metal loss, the margins against local collapse were higher than at Area 1, with the next lowest collapse pressure being 37 barg associated with Location 8.8 (6 o'clock position around circumference of weld). The areas of metal loss were therefore considered to remain acceptable for operation with a design pressure of 15 barg in accordance with the guidance of API 579.
